Pepsi Bottling Plant Rocking Slab Stabilization

Erosion beneath warehouse concrete slab floor causing uneven joints and rocking slabs at **Pepsi Bottling Plant** in Nashville, TN

Contractor Mid-South Concrete Leveling (MSCL)	Location Nashville, TN	Product Used Terrathane™ 24-003
---	----------------------------------	---

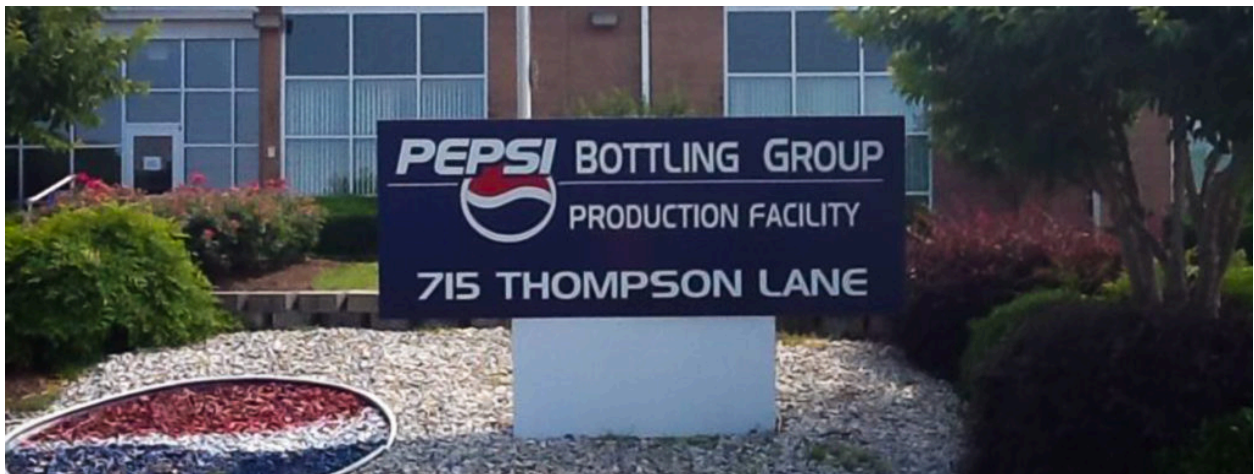
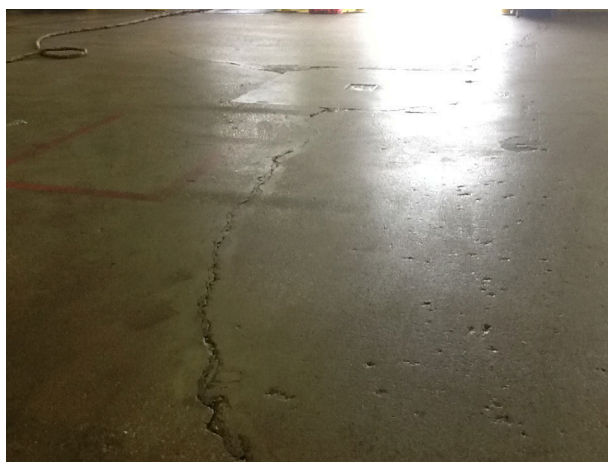
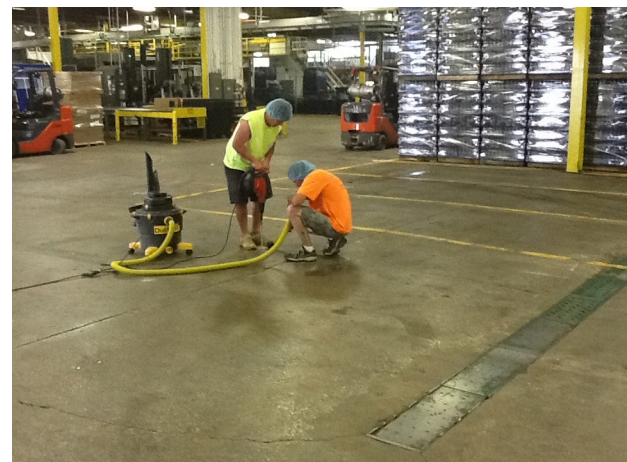
Project Gallery

- Erosion beneath warehouse concrete slab floor causing uneven joints and rocking slabs
- Forklift traffic travelling over the unsupported slabs caused the slabs to rock up and down and created breaks and fractures called “joint spalling”
- Rocking and unlevel slabs were causing jolts and bumps to forklifts, leading to falling loads and safety issues

- Clean out all joints and remove the debris

- Inject TerraThane™ 24-003 polyurethane on a 4 ft grid pattern to fill joints, voids and stabilize rocking slabs

- Stabilized over 130 ft of slabs
- Work performed to minimize operational interruption
- Fast cure time ensured the installation locations would be drive-able during the same day as the installation
