Kentucky Water Treatment Center Walkway Collapse and Soil Subsidence Stabilization

Soil Subsidence and base soil loss led to sinkhole-like conditions and the collapse of a walkway at a Kentucky Water Treatment Center.

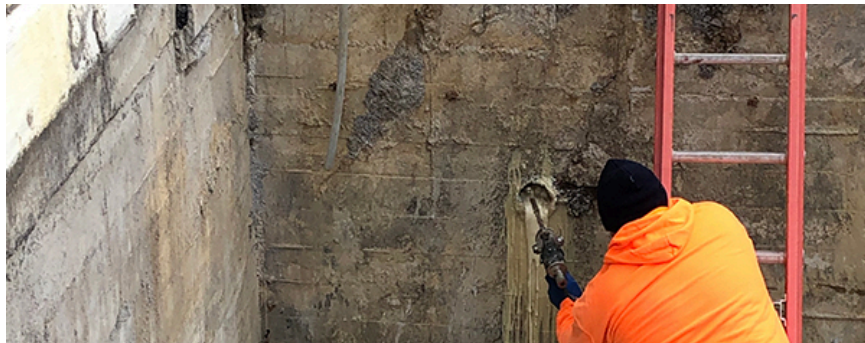
In Fort Thomas, KY, [The Northern Kentucky Water District \(NKWD\)](#) had quite the jolt. One day everything was fine, the next a 10ft x 8ft section of an asphalt walkway had collapsed next to one of their water treatment center's office buildings! The collapse wasn't caused by a sudden issue, but by a soil subsidence problem that had developed over time.

The walkway was located between NKWD's office building and its water treatment tanks. Below the walkway were 36" diameter pipes at approximately 10' below grade

that penetrated a concrete wall, that supported a utility access point at the end of the walkway. Water eventually penetrated the pavement and found its way to the annular voids around the pipe penetrations and caused a hole in the wall's earthen footing, leading to severe soil subsidence which created a sinkhole-like condition that caused the walkway to collapse.

United Dynamics approached the project by spray applying the 24-070 to the hole at the base of the wall. The polyurethane spread throughout the void and re-established contact between the wall and the support soil. United Dynamics continued to spray apply the 24-070 to form a 6ft tall 8ft x 5ft monolith of polyurethane which encapsulated the pipes, stabilized the hole, and [sealed the pipe](#) penetrations to prevent any future soil migration. The polyurethane monolith also provided a structural "bridge support" to further protect the pipes.

"The pipes and hole were void-filled and encapsulated within a day ensuring the area was stabilized against future soil subsidence. The light-weight qualities of the 24-070 also reduced overburden stress on the fill material," said Minzenberger. "The GC was
