NCFI Terra-Lok™ 24-120 Used to Stabilize Culvert and Turnpike in NJ

Culvert soil loss was resulting in the weakening of the roadway and causing it to settle. To repair the issue, ECRR treated the soils with NCFI's Terra-Lok™ 24-120.

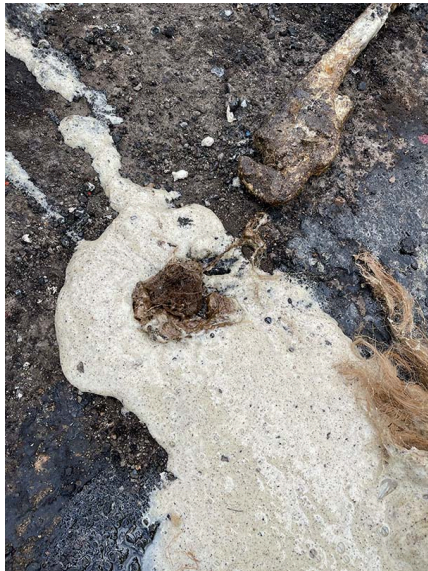
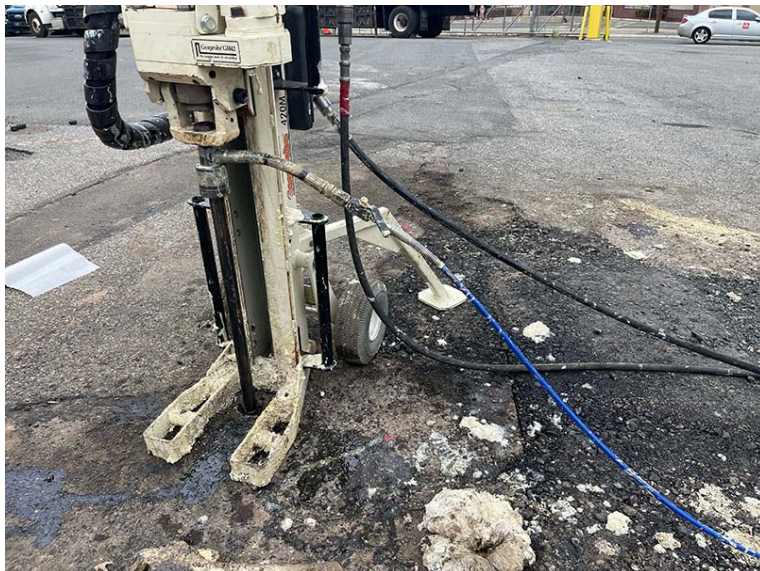
After a 3-day installation, material travel was confirmed through visual observation in the culvert. The polyurethane had sealed the cracks and was seen around the perimeter of the culvert. The project was a complete success and helped the NJTA avoid weeks of repairs and delays and tens of thousands of dollars with alternative methods.

ECRR took soil samples onsite to confirm the moisture content for determining the 24-120's chemical reaction. ECRR then approached the project by injecting the 24-120 on a 2ft grid pattern at 8ft depths. As the culvert was 25ft below the surface, the injection pattern allowed for excellent soil permeation at optimal depth to stabilize the culvert, roadway, and the soil in between.
