Reeds Creek Fish Hatchery Leakage Repair With Polyurethane

About The Project

Contractor High Caliber Coatings	Location Reeds Creek Fish Hatchery, WV	Product Used Terrathane™ 24-042
-------------------------------------	---	------------------------------------

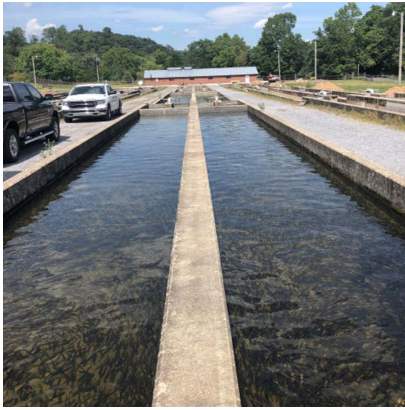
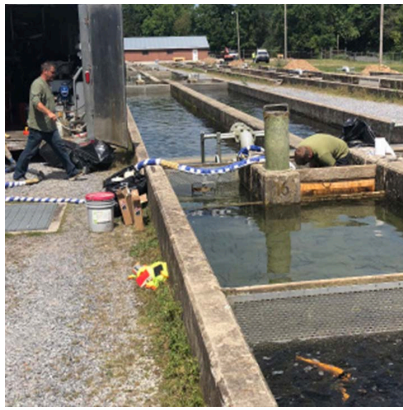
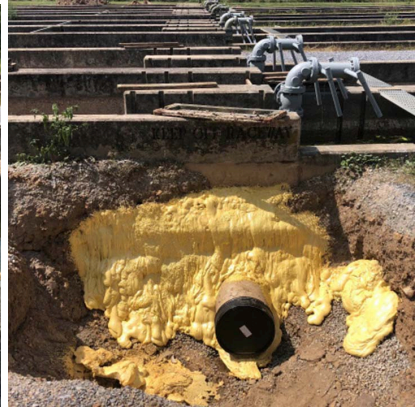
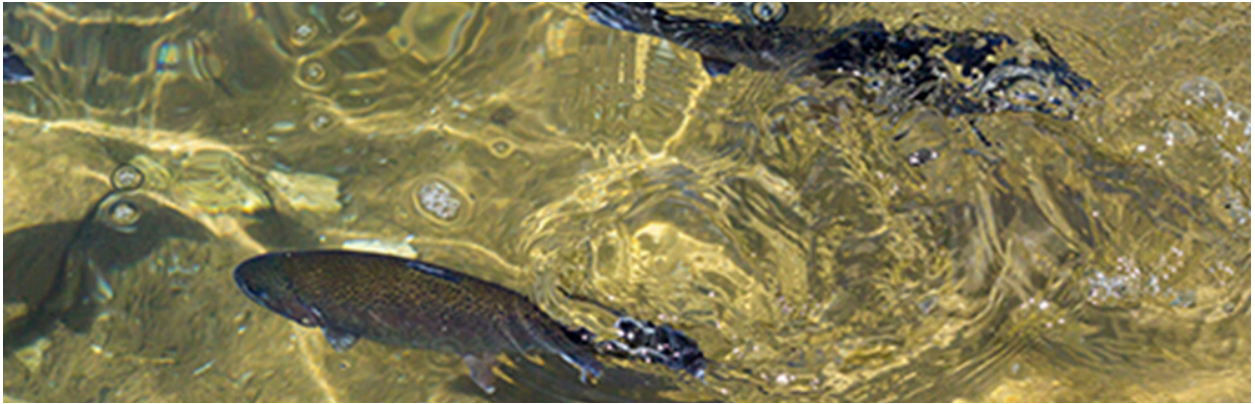
Project Gallery

The Reeds Creek Fish Hatchery consists of 8 raceways that have 10 overflow “boxes” distributed across the raceway. The boxes help ensure water overflow would be controlled by distributing overflows through a network of 70- year old 10” and 16” asbestos-concrete or transite pipes that feed into a 24” line to bring the water to an overflow pond. The pipes were experiencing leakage throughout the system that was causing soil washout and, subsequently, large voids underneath the raceway and settlement and cracking in isolated areas of the raceway that was leading to additional water loss. This necessitated a plan for hatchery leakage repair.

- The system needed to be remedied quickly without causing issues for the fish in the hatchery. This is where the [TerraThane 24-042](#) NSF/ANSI 61 certified polyurethane was the right solution.
- The 24-042 NSF/ANSI 61 clean drinking water standards ensured the water quality was not in any way contaminated.
- The polyurethane had to be able to seal the transit pipes from the exterior in a few zones where previous CIPP (Cured in Place Pipe) had some leakage issues.
- The polyurethane must be able to [fill the voids](#) underneath the hatchery and create positive contact between the raceways and the base soils, reestablishing load back to the soil without causing damage.

- As to void-filling, 24-042 is primarily a void-filling polymer which is designed to have optimal flow for filling large cavities without an abundance of expansive force. 24-042's slow cure time ensured the polymer's spread and expansion [filled all of the cavities within the void](#) area from one injection location. Additionally, the final cured system produces a hard shell that helps distribute the load through the foam and into the base soils.
